# In situ investigation of stone heritage sites for conservation purposes: a case study of the Székesfehérvár Ruin Garden in Hungary

This paper demonstrates the application of in situ diagnostic tools to document stone heritage sites prior to conservation interventions using a Medieval ruin of Central Europe (Székesfehérvár, Hungary). The applied methods included lithological mapping and characterisation and mapping of decay forms as well as in situ measurements of physical parameters such as Schmidt hammer rebound, moisture content and micro-drilling resistance. The combination of these methods allowed the condition assessment of different lithotypes and demonstrated the role of micro-fabric, mineralogical composition and climatic conditions in stone durability. Differences were found in the properties and in the weathering forms of fine-grained and medium-grained porous oolitic limestone and travertine. The black crust observed in porous limestone is less prone to detachment on medium-grained oolitic limestone ashlar, while scaling was observed on fine-grained oolitic limestone blocks. The micro-drilling resistance of exposed porous limestone showed higher drilling resistance at

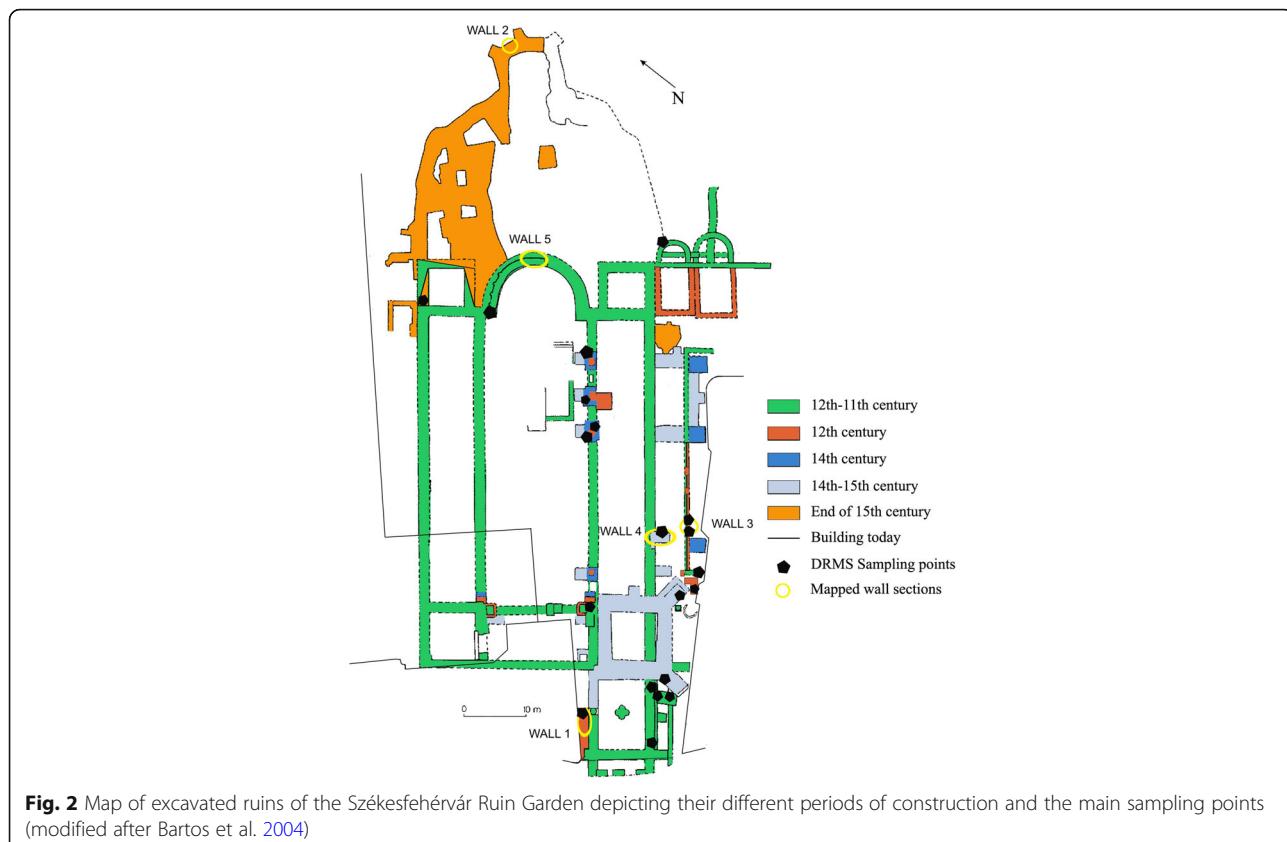
**Fig. 2** Map of excavated ruins of the Székesfehérvár Ruin Garden depicting their different periods of construction and the main sampling points (modified after Bartos et al. 2004)

the distribution of the different lithotypes and the different construction periods to which the ruins belong (Fig. 2). Their location in the site, i.e. sheltered (walls 1, 3 and 4) or unsheltered areas (walls 2 and 5), was also taken into account. The investigated side of wall 1 faces southeast, wall 2 north, wall 3 northwest, and wall 4 and 5 northeast. The total mapped area covered about 30 m<sup>2</sup> of the existing wall surfaces (Theodoridou 2009). Three different kinds of maps were designed for each wall section: (i) the first series of maps depicts the different construction periods of the selected section of the walls, (ii) the second shows the distribution of the different lithotypes over the wall sections, and (iii) the visible weathering forms on the building materials. For the last category of mapping, the first classification was developed by the working group “Natural stones and weathering” (Fitzner et al. 1995) with several publications that followed, e.g. Fitzner and Heinrichs 2002, Fitzner et al. 1997, 2002, Viles et al. 1997 and the lately published glossary by ICOMOS-ISCS (2008).

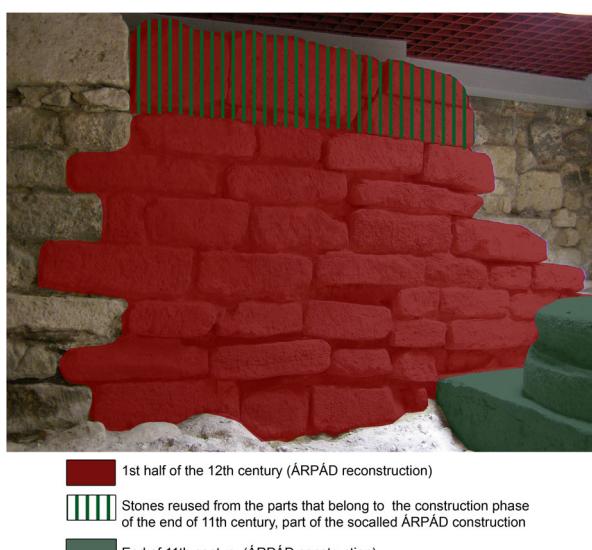
**Fig. 3** Wall 1—Map of construction phases

Figures 3 and 4 show the maps of construction phases and lithotypes respectively of a representative wall section (wall section 1).

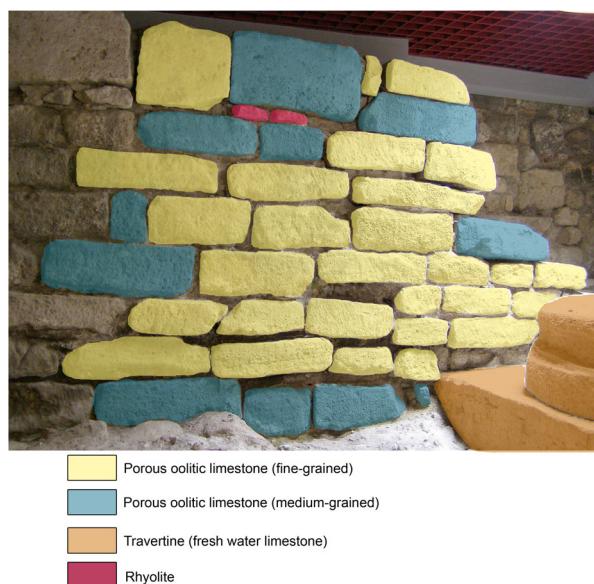
**Fig. 4** Wall 1—Map of lithotypes

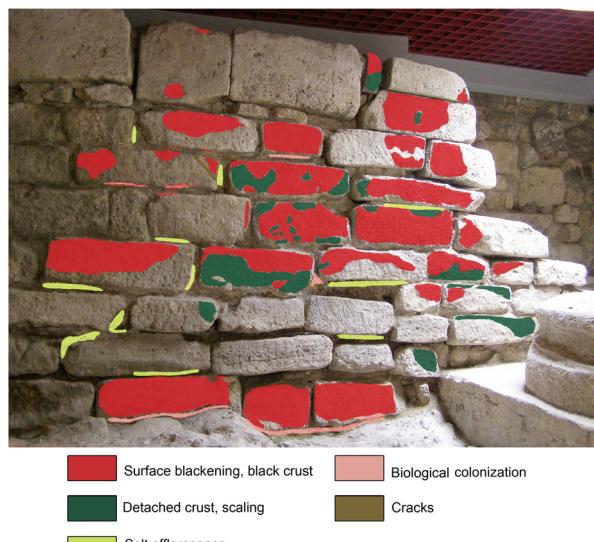
**Fig. 5** Wall 1—Map of weathering forms

seen, for instance on the blocks of oolitic limestone of wall 4. Exogenic deposits in combination with materials derived from the stone created black and white crust in different blocks of the aforementioned lithotype (e.g. wall 1 (Fig. 5) and wall 4). Detachment of the black crust was observed in the case of fine-grained oolitic limestone (e.g. wall 1 (Fig. 5)).

Additionally, salt efflorescence (e.g. wall 1 (Fig. 5)) and biological colonisation were observed on the historical mortar of the ruins. Especially the latter one was intense in the areas that were close to the ground level (e.g. wall 1 (Fig. 5), walls 3 and 4). In a few cases, the presence of algae expanded to the adjacent blocks of rhyolite (e.g. wall 2) and travertine (e.g. wall 4).

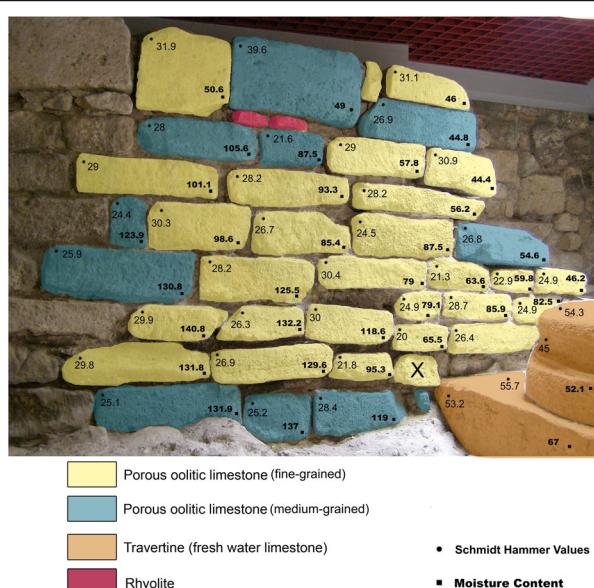
The Schmidt hammer values and the moisture content measured on the blocks of the selected walls were depicted on the maps of lithotypes. Figure 6 shows the representative example of wall 1. The Schmidt hammer values were recorded higher for the more compact stones, such as rhyolite and granite, with the red limestone performing also relatively high rebound values. Most types of limestones performed relatively low values, with the oolitic showing generally lower values than the travertine.

**Fig. 6** Wall 1—Schmidt hammer and moisture content values

The moisture content values were also presented on the same maps (e.g. Fig. 6). The fluctuation of the values for the same lithotype was related to the influence of the different environmental conditions on the stone materials; blocks of the same lithotype showed higher moisture values where they were located in shadow areas, especially in the covered parts of the monument. For instance, in the case of wall 1 (Fig. 6), the blocks which were on the right part of the wall, where the sunlight passes through a transparent glass located on the right top of the ceiling, were associated with lower moisture content values than the blocks that had constantly been under shadow. Moreover, in all cases, the blocks located closer to the ground had higher moisture content than blocks of the same lithotype which were located at a higher distance from the ground level.

Regarding the Schmidt hammer application (e.g. Fig. 6), the results contributed to a quick and non-destructive estimation of the materials strength properties. Furthermore, weathering of the materials surfaces could be detected by the changes in surface strengths measured by the method as, for instance, the increase in surface strength due to the formation of weathering crusts. This decay pattern of oolitic limestone was also recorded in previous studies (Török 2003). It should be also clarified that despite the fact that the technique is considered a non-destructive one, small impound marks are produced on the surface of tested stones. Hence, the application of the test was avoided on deeply weathered stone blocks.

relative and not absolute values, can give a profile of the different values in different measured points. The achieved measurements (e.g. Fig. 6) presented a good indicator of the influence of climatic conditions for each block, e.g. higher moisture content values for the same lithotype in case of blocks located closer to the ground or in areas that were constantly in shadow. It has been documented that water uptake can influence the durability of porous limestones (Török et al. 2007a; Vázquez et al. 2016; Hassine et al. 2018), and thus, it is also linked with the intensity of frost damage (Al-Omari et al. 2015). Water and moisture content controls the durability of travertine, too (Török and Vásárhelyi 2010). Many of the measured points with higher moisture content values had already presented salt efflorescence and/or biological colonisation. Therefore, the use of this low-cost technique could contribute significantly to the identification of endangered zones.

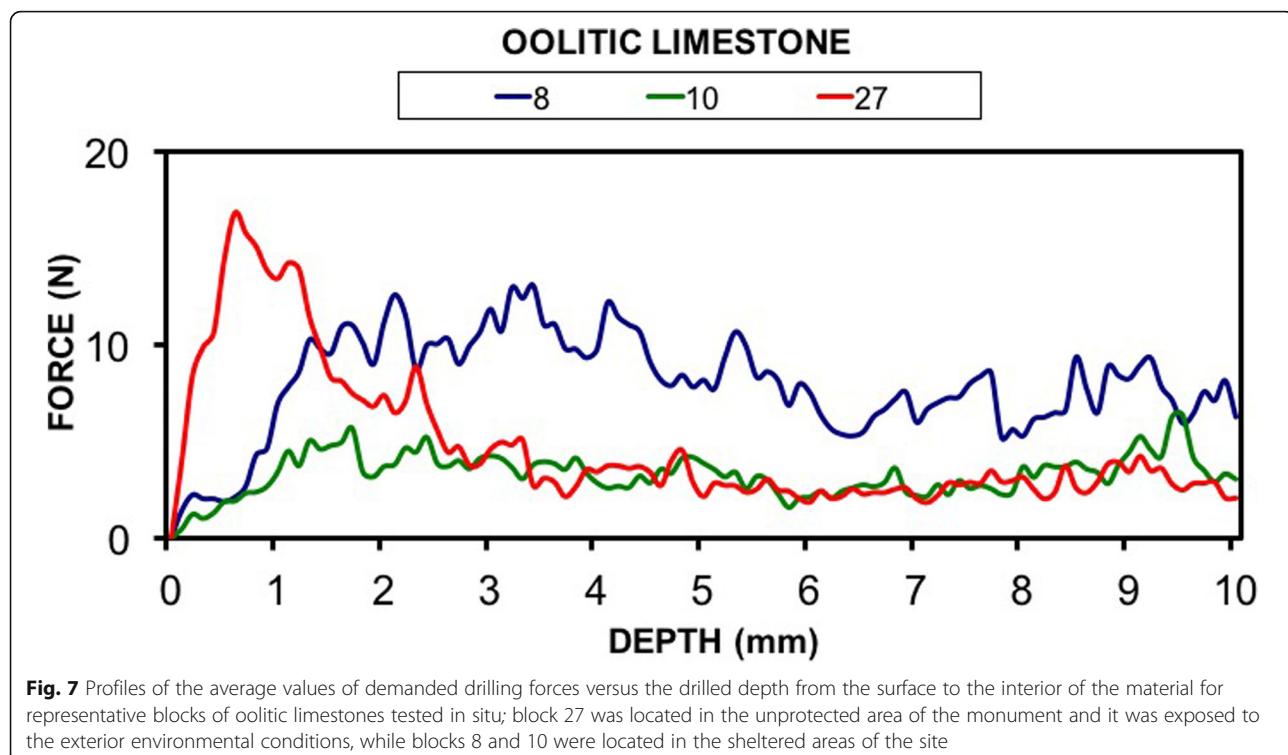
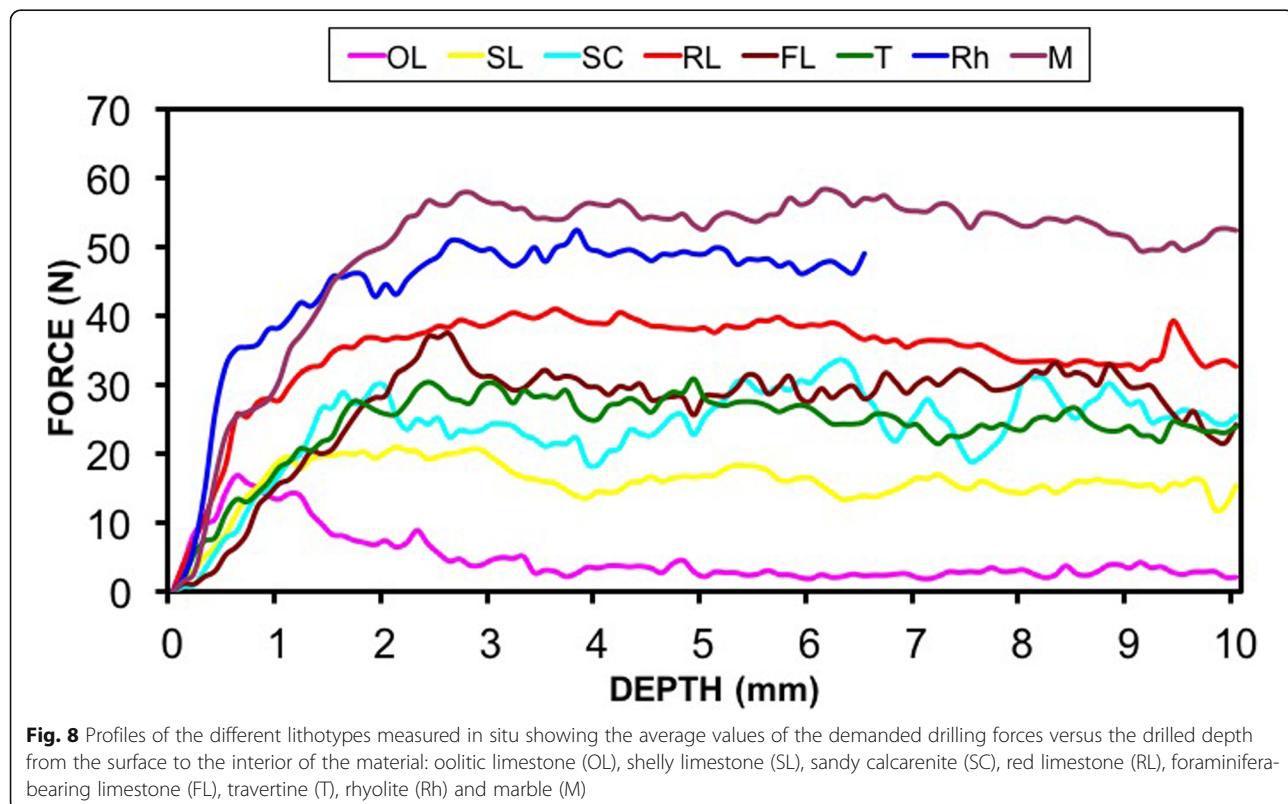
material. This was not the same for the oolitic limestone located in the protected areas of the monument (blocks 8 and 10). The profiles of the shelly limestone, sandy calcarenite and red limestone (Fig. 8) showed an increase in the drilling resistance during the approximately top-most 2 mm.

In the current research, the average demanded drilling forces gave a good estimation of the strength parameters of the tested materials, which agree well with the literature (e.g. Theodoridou et al. 2015, Exadaktylos et al. 2000, Tiano et al. 2000, Delgado Rodrigues et al. 2002, Pamplona et al. 2008, Vázquez et al. 2016). The drilling profiles corresponded to the microfabric of the materials close to the surface, e.g. higher heterogeneity for the sandy calcarenite due to the presence of quartz grains in comparison with the compact red limestone (Fig. 8). Moreover, the results achieved by in situ measurements depicted the occurring weathering phenomena, such as the presence of crust on the surface of oolitic limestone by showing higher drilling resistance on the topmost millimetre (Fig. 7, block 27). At greater depth, the samples showed lower values (Figs. 7 and 8).
