# Simple evaluation of the degradation state of cultural heritage based on multi-view stereo

In this study, degradation of cultural heritage is discussed based on the comparison between the present shape of the Wareishi Rock Cliff Sculpture and its replica made 30 years ago through simple three-dimensional measurement using a multi-view stereo. The Wareishi Rock Cliff Sculpture, an important cultural property of Hiroshima Prefecture, is located near a shoreline. Local people often highlight that the sculpture seems to have recently been suffering from rapid degradation because of the direct impact of tidal ebb and flow. The present three-dimensional shape of this sculpture was investigated through multi-view stereo technique to accurately estimate the current degradation state. The same investigation was performed on the replica of the sculpture made in 1986 using a mold and exhibited in the Hiroshima Prefectural History Museum. The difference between the present shape of the sculpture and that of the replica revealed through the above investigation can be regarded as degradation of the sculpture that has occurred over the previous 30 years. The result is as follows. The differenc

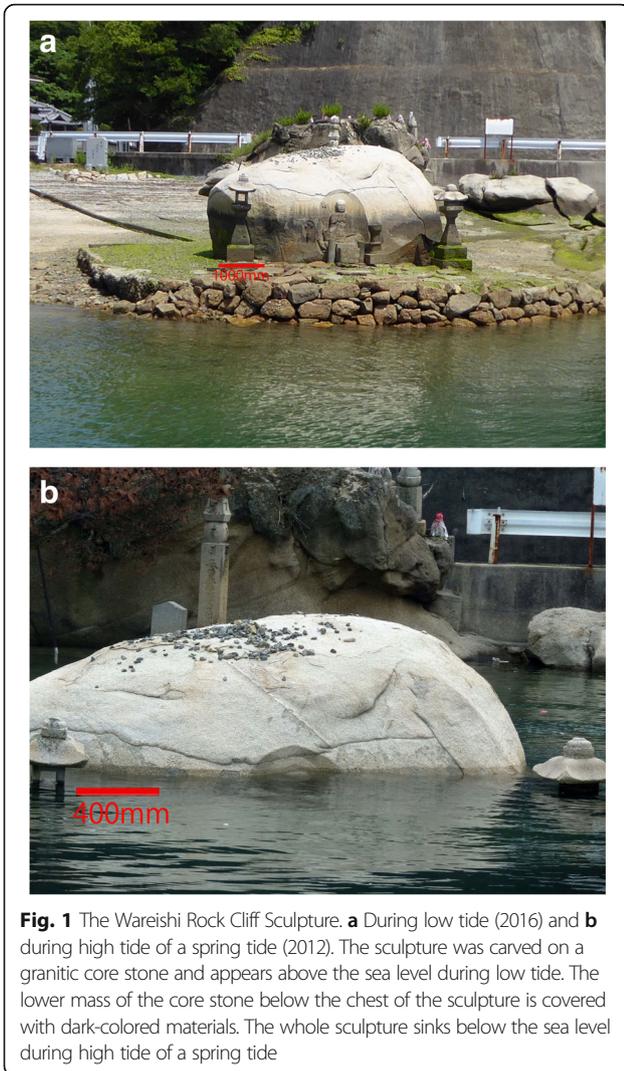
**Fig. 1** The Wareishi Rock Cliff Sculpture. **a** During low tide (2016) and **b** during high tide of a spring tide (2012). The sculpture was carved on a granitic core stone and appears above the sea level during low tide. The lower mass of the core stone below the chest of the sculpture is covered with dark-colored materials. The whole sculpture sinks below the sea level during high tide of a spring tide

The target of this study is the Wareishi Rock Cliff Sculpture (Hiroshima Prefecture 2008) (Fig. 1a), designated as an important cultural property of the Hiroshima Prefecture, in the Sagi Island, Mihara City, Japan (Fig. 2). An inscription besides the sculpture shows that it was carved in A.D. 1300, directly on a core stone (Holmes 1978) of Cretaceous Hiroshima Granitic Rocks, located near a shoreline. No salt efflorescence has ever been reported on the core stone. The sculpture is a bas-relief of an approximately 1 m tall sitting Buddha. The ~4 m globular granitic core stone appears above the sea level during low tides (Fig. 1a), whereas a part or all of it sinks below the sea level during high tides (Fig. 1b). The average

sea level during the high tide of 2016 was estimated to be around the chin or neck of the sculpture based on the tide table in Itozaki (Japan Meteorological Agency 2017), the nearest point of the Meteorological Agency (Fig. 2). The lower mass of the core stone below the chest of the sculpture is covered with dark-colored materials that seem to be algae (Fig. 1a).

The present shape of the core stone is nearly globular without extreme encroachments (up to several centimeters in depth: Fig. 1a). If weathering of the core stone was severe, some geomorphological features should be detected. The area where the displacement was detected between the original sculpture and the replica does not cover a wide range (only  $\sim 0.56\%$ ), indicating that the current detectable degradation of the Wareishi Rock Cliff Sculpture has occurred only in limited areas.

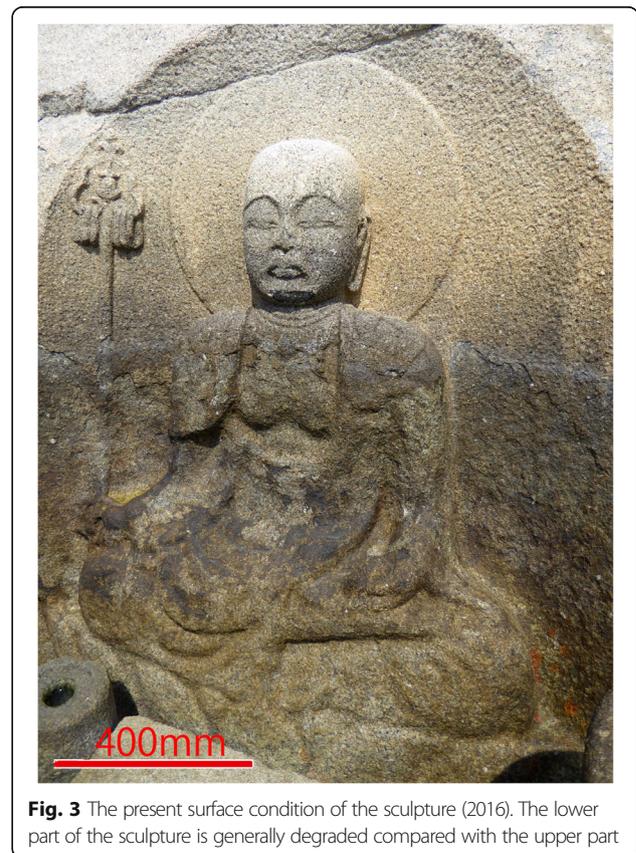
**Fig. 3** The present surface condition of the sculpture (2016). The lower part of the sculpture is generally degraded compared with the upper part

About the degradation state of the sculpture, the original surfaces are supposed to be still retained on the upper body, including the face, because of the sharpness of the edges (Fig. 3). On the contrary, the edges of the lower body, including the garment, are not sharp, indicating that the lower part of the sculpture is degraded more than the upper part (Fig. 3). Local people emotionally insist that the degradation of the sculpture is progressing rapidly because of the impact of sea waves; however, this notion does not have any scientific data. Because an investigation must be conducted only during low tide, quantitative data about the sculpture's degradation state have not been obtained to date.

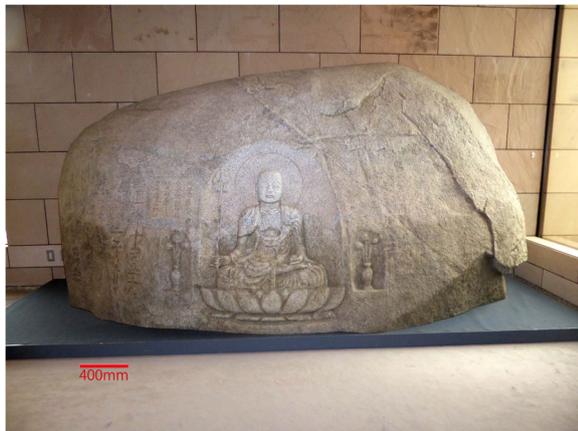
**Fig. 4** Replica in the Hiroshima Prefectural History Museum (made in 1986). The replica has continuously been located inside the Museum. The lower mass below the stomach of the sculpture is dark-colored

There is a replica of the Wareishi Rock Cliff Sculpture made of fiber-reinforced plastics (FRP) in 1986 (Fig. 4), which is located in the Hiroshima Prefectural History

The lower part of the replica is also dark-colored, but the upper boundary of the darkened part is around the stomach of the sculpture (Fig. 4), i.e., lower than that of the present Wareishi Rock Cliff Sculpture, around the chest (Fig. 1a).

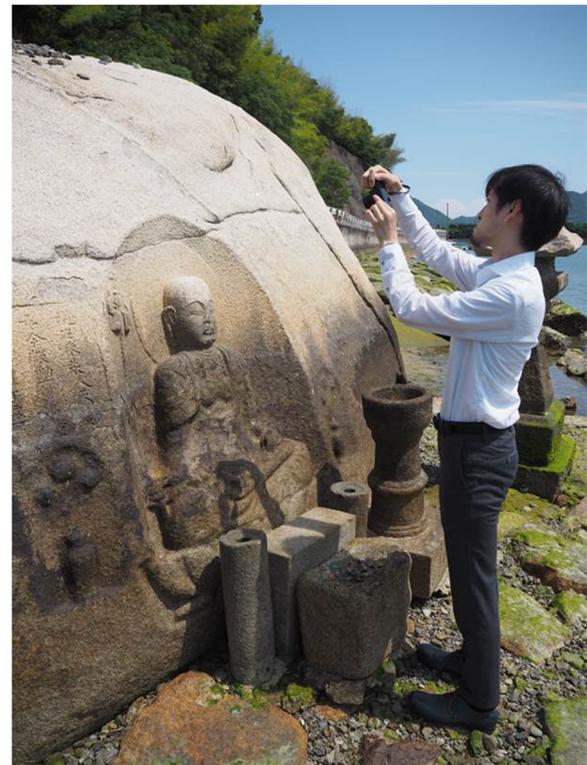
**Fig. 5** Photographing the Wareishi Rock Cliff Sculpture. It took approx. 6 min using a compact digital camera basically by one person during low tide. The person is 170 cm tall

The measurement is required to be carried out easily and quickly because it should be done only during low tide for efficiency. For this reason, multi-view stereo technique based on photogrammetry was used in this study. This technique measures the unevenness of targets not only on particular spots but also on the whole area by taking photographs from various viewpoints (Fig. 5) and matching them. In this study, this technique was applied to detect

the planar distribution of displacement. Fifty-seven photographs (~70 cm wide each) were taken of the original sculpture, and 43 photographs (~120 cm wide) of the replica were taken using a digital camera “PowerShot G7X” from Canon Company. The measurement, conducted in June 2016 by a single person, took ~6 min for the sculpture and ~4 min for the replica.

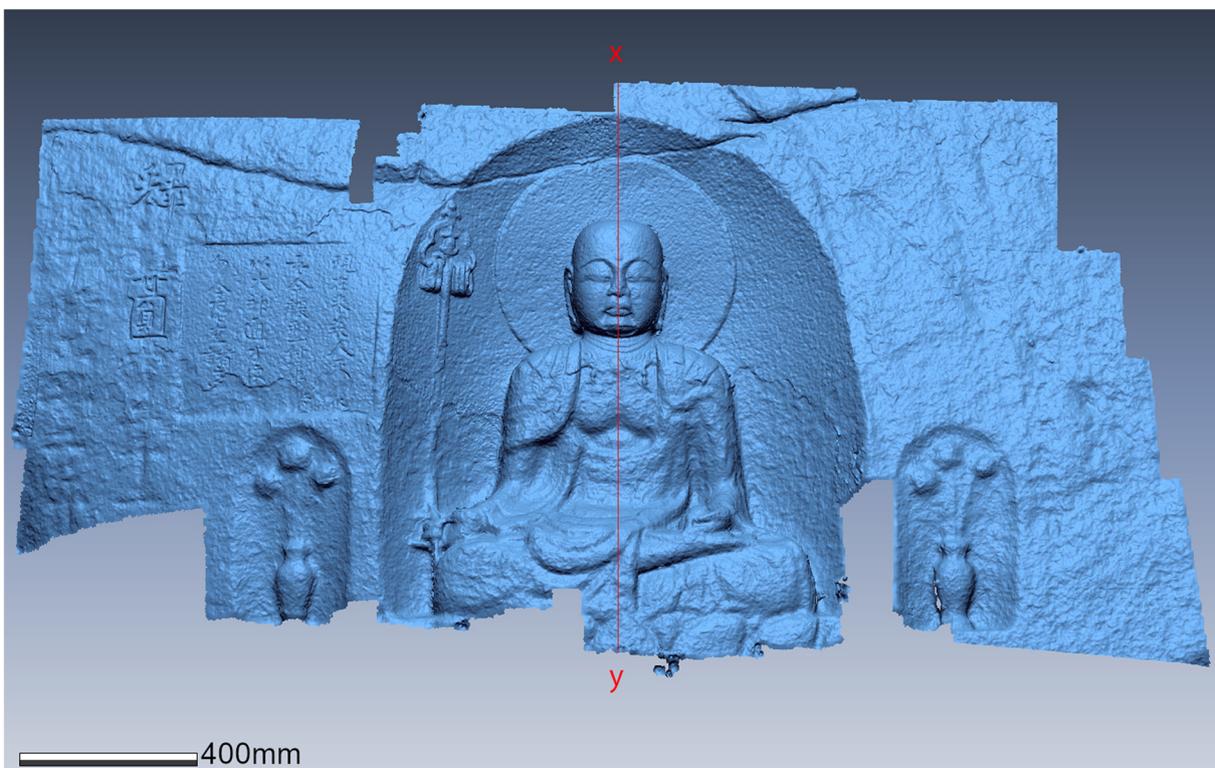
**Fig. 6** Orthographic projection of the Wareishi Rock Cliff Sculpture. The x-y line shows the position of the cross section (Fig. 10)

model of the original sculpture is shown in Fig. 6 and that of the replica in Fig. 7.

After adjusting each three-dimensional form model, the smallest deviation between the Wareishi Rock Cliff Sculpture (Fig. 6) and the replica (Fig. 7) was calculated by aligning the three-dimensional models through the method of iterative closest point (ICP), minimizing the total deviation of the models (Besl and McKay 1992). The software of Geomagic XOS of the SMARTTECH Company was used in this step. The calculation was carried out on the 31 partial three-dimensional form models (Fig. 8), to avoid impact from broad distortion caused by swelling or shrinkage of FRP. Each partial model area (Fig. 8) was selected to keep the broad distortion smaller than local displacements. Measurement error of this method is theoretically estimated to be less than 0.7 mm based on former research about multi-view stereo (Sakai 2015). Places where more than 3 mm of displacement was detected were extracted as the degraded area in the previous 30 years by this study to recognize the difference by naked eyes. The distortion

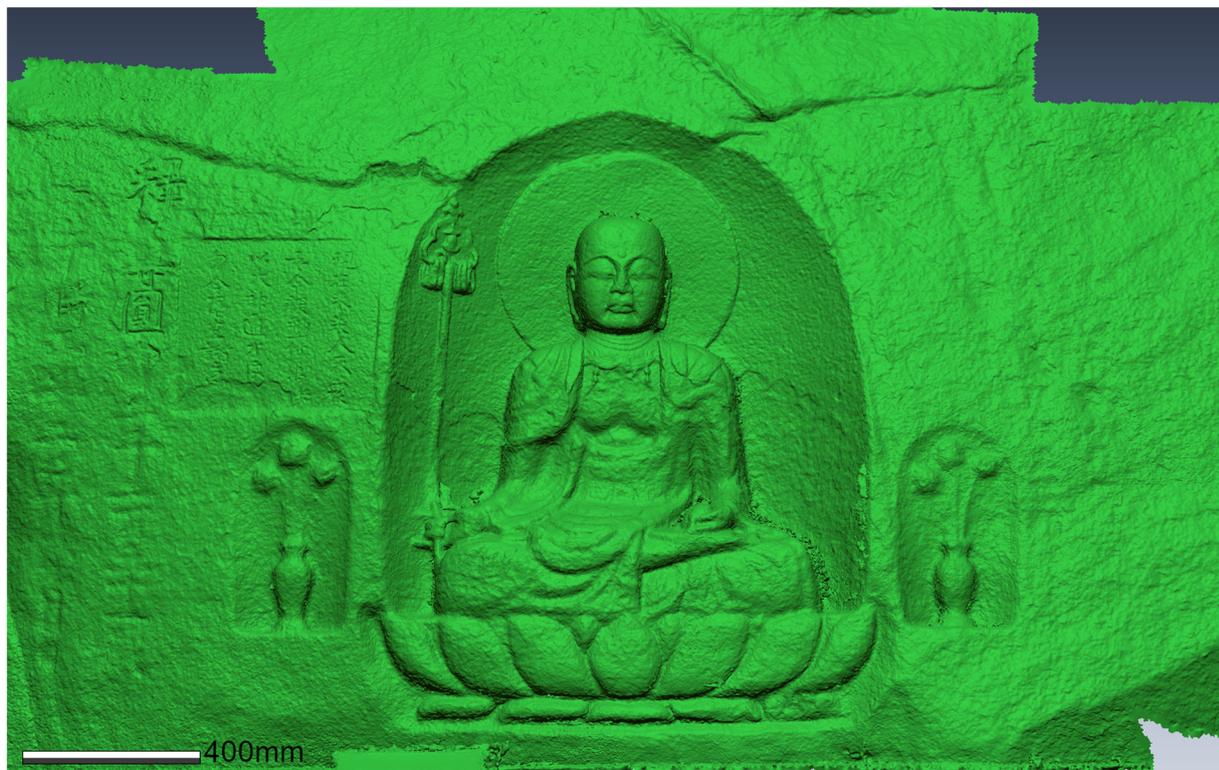
**Fig. 7** Orthographic projection of the replica

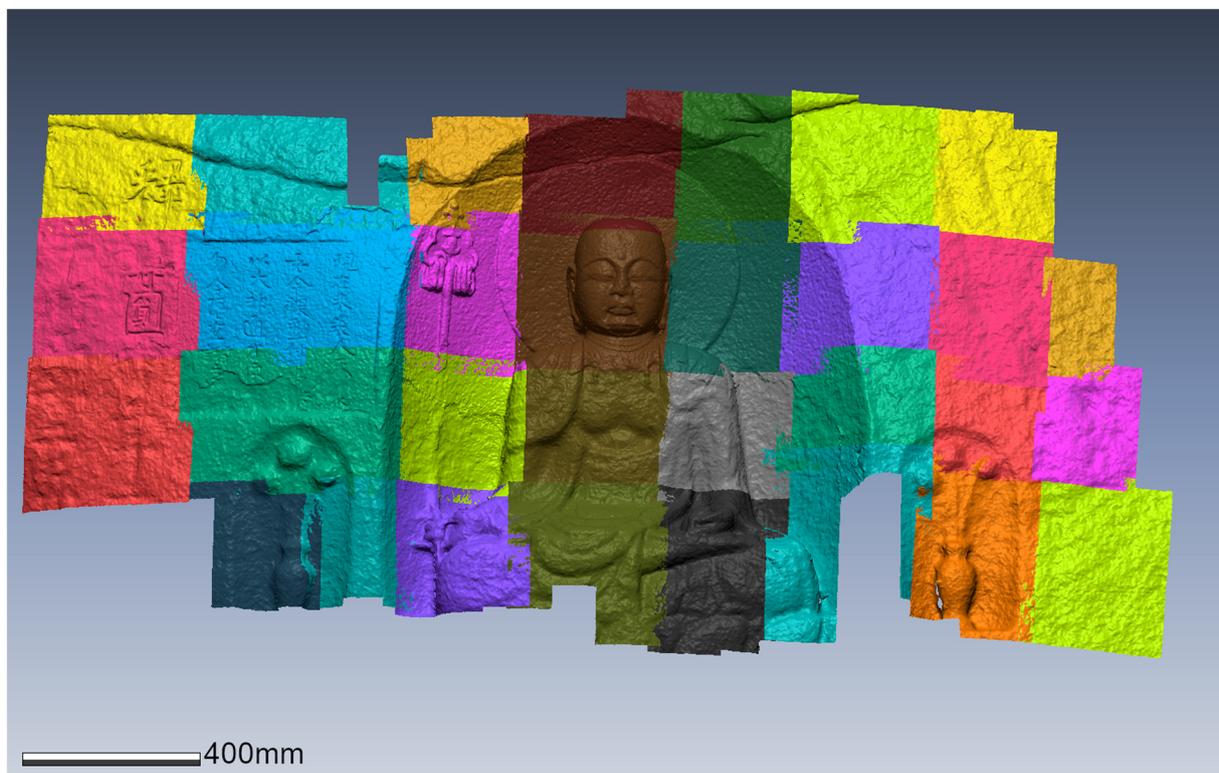
**Fig. 8** Positions of the partial three-dimensional form models where the difference between the original sculpture and the replica was calculated. Each partial model area was selected to keep the broad distortion smaller than local displacements, free from swelling or shrinkage of FRP

detected within a partial three-dimensional form model (Fig. 8) is always less than 3 mm; thus, the influence of swelling or shrinkage of FRP is negligible.

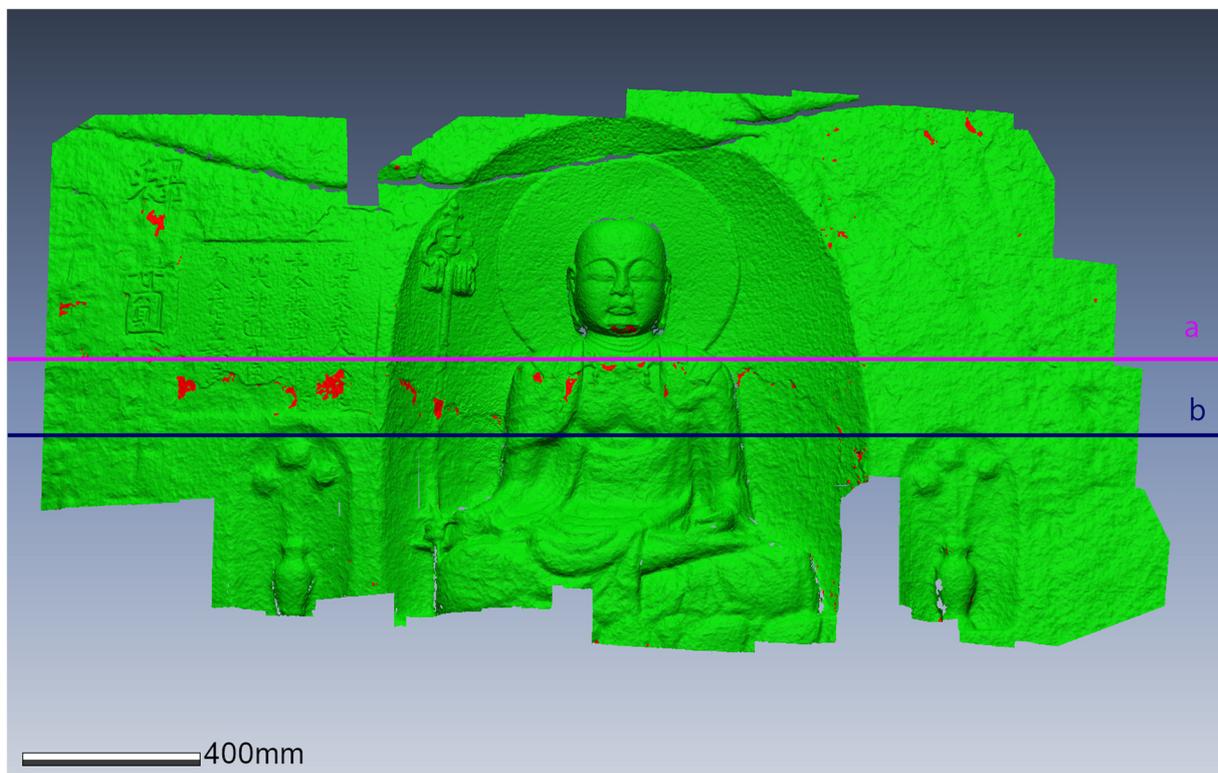
**Fig. 9** Displacement map between the Wareishi Rock Cliff Sculpture and the replica. Ortho-image facing to the replica. Red represents more than 3 mm of the detected displacement, and green represents less than 3 mm of the detected displacement. **a** (pink line): The upper line of the present alga lushness area. **b** (blue line): The upper line of the alga lushness area in 1986 (Lines “a” and “b” were drawn by the same person based on the naked eye observation)

The difference between the shapes of the original sculpture and the replica was detected mainly on the middle part of the core stone constituting a horizontal belt ~20 cm parallel to the sea surface (Fig. 9). The upper surface of the belt where displacement concentrates concurs with the upper surface of the

dark-colored area of the original sculpture (Figs. 1a and 9), and the lower limit of the belt concurs with the upper surface of the dark-colored area of the replica (Figs. 4 and 9).

The detected displacement areas are scattered mainly within the belt-shaped area where dark colorization has progressed in the previous 30 years. The dark-colored area, the upper line of which concurs with the average seawater surface during high tide, is considered to relate to the supply of the seawater during high tide (Fig. 10). Then, it is possible that the rise in sea level in the previous 30 years has resulted
